**Flood Control Project Maintenance  
Levee Inspections****LMA District Cover Sheet****Spring 2016 Levee Inspection Results****Reclamation District No. 0501 Ryer Island**

**Spring 2016 Levee Inspection Results**

**Reclamation District No. 0501 Ryer Island**

Waterway			Bank	Unit Miles
Unit No. 01 Steamboat Slough			Right	6.71
	Spring (March - May)	Summer (June - August)	(September - November) Fall	Winter (December - February)
Unit Maintenance Rating (Fall Only)				
Date of Inspection	3/24/2016 - 3/24/2016			
DWR Inspector	Herman Phillips			
Accompanied By	Nicolas Zepeda RD 501

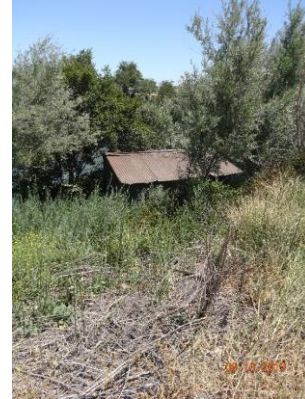
Photo 2 of 2 : UCIP\_SP\_2016\_32542\_59023.jpg

Comment Code					
Inspector Comment					
FS_ID:32542					
DS_ID:21059					
EP_NO: N/A					
Repair Type: Non-Urgent					
Crossing Status: Found					
UCIP Comments: Need to determine status of crossing. Horizontal and vertical cracks present on stand pipe located on landward side. Dense vegetation limits the inspector's visibility to identify signs of pipe failure (leaks) along the waterward slope. Recommend removing vegetation along pipe alignment to conduct proper inspection of structure and appurtenances.					
FIELD_STRUCT_DESC: 12-inch steel pipe through the levee, 6.0 feet below the crown. 2-inch conduit line through levee. Pump and gate valve on waterward slope. Pipe exposed on landward side. (USACE-1959). This entry matches the Drainage or Irrigation Structure referenced in O&M manual (HLM 6.90).					
FS Date: 6/13/2013

View of waterward side. Dense vegetation along levee slope.

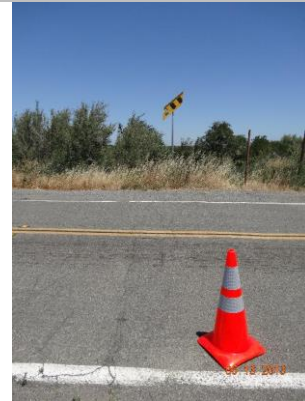
Photo 1 of 2 : UCIP\_SP\_2016\_42118\_72902.jpg

LM Start	6.40	Rating **	M	Issue No.	147
LM End	6.40	Issue Type +	En	Location *	LS
Category	Supplemental			GPS Latitude/Longitude	
				Start	End
Item	DWR UCIP Field Study			38.290356 °	38.290356 °
				-121.627488 °	-121.627488 °
DWR ID					
Comment Code					
Inspector Comment					
FS_ID:42118 DS_ID:24054 EP_NO: N/A Repair Type: Non-Urgent Crossing Status: Indicator Found UCIP Comments: Need to determine encroachment number issued for pipe installation. FIELD_STRUCT_DESC: Gasline through levee at an angle with unknown depth. Markers visible on both sides. FS Date: 6/13/2013

Markers visible on waterward side.

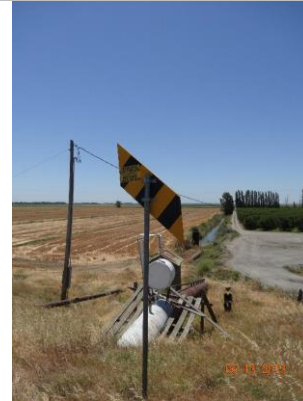
Photo 2 of 2 : UCIP\_SP\_2016\_42118\_72901.jpg

LM Start	6.40	Rating **	M	Issue No.	147 (cont)
LM End	6.40	Issue Type +	En	Location *	LS
Category	Supplemental			GPS Latitude/Longitude	
				Start	End
Item	DWR UCIP Field Study			38.290356°	38.290356°
				-121.627488°	-121.627488°
DWR ID					
Comment Code					
Inspector Comment					
FS_ID:42118 DS_ID:24054 EP_NO: N/A Repair Type: Non-Urgent Crossing Status: Indicator Found UCIP Comments: Need to determine encroachment number issued for pipe installation. FIELD_STRUCT_DESC: Gasline through levee at an angle with unknown depth. Markers visible on both sides. FS Date: 6/13/2013

Marker visible on landward side.

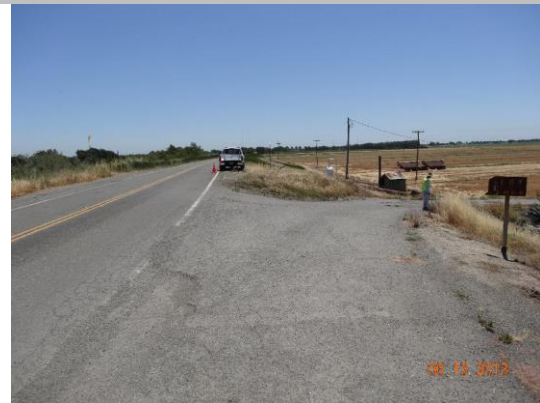
Photo 1 of 2 : UCIP\_SP\_2016\_19668\_33446.jpg

Comment Code					
Inspector Comment					
FS_ID:19668 DS_ID:21057 EP_NO: N/A Repair Type: Non-Urgent Crossing Status: Found UCIP Comments: Crossing was operating during inspection; Dense vegetation limits the inspector's visibility to identify signs of pipe failure (leaks) along the waterward slope. Recommend removing vegetation along pipe alignment to conduct proper inspection of structure and appurtenances. FIELD_STRUCT_DESC: 1 of 2: 30-inch steel pipe through the levee, 9.5 feet below the crown. Cutoff wall around pipe at center of levee. Siphon breaker at landward slope. Primer tanks on landward slope. Pipe exposed on both slopes. This entry matches the Drainage or Irrigation Structure referenced in O&M manual (HLM 6.90). Pipe installed under Permit No. 611 in 1934. Section of pipe between shoulders removed and replaced with 30-inch steel pipe under Permit No. 2497 (1959). FS Date: 6/13/2013

Overview of levee crown--multiple crossings within a 50 foot stretch.

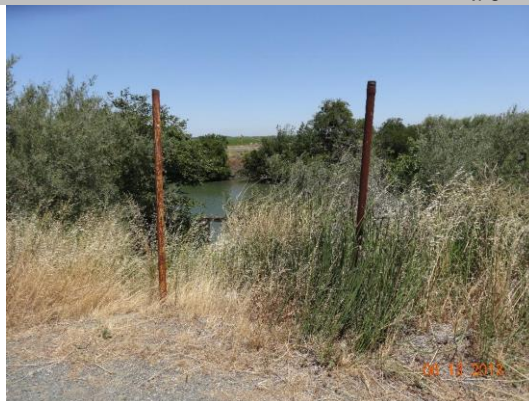
Photo 2 of 2 : UCIP\_SP\_2016\_19668\_33443.jpg

Comment Code					
Inspector Comment					
FS_ID:19668 DS_ID:21057 EP_NO: N/A Repair Type: Non-Urgent Crossing Status: Found UCIP Comments: Crossing was operating during inspection; Dense vegetation limits the inspector's visibility to identify signs of pipe failure (leaks) along the waterward slope. Recommend removing vegetation along pipe alignment to conduct proper inspection of structure and appurtenances. FIELD_STRUCT_DESC: 1 of 2: 30-inch steel pipe through the levee, 9.5 feet below the crown. Cutoff wall around pipe at center of levee. Siphon breaker at landward slope. Primer tanks on landward slope. Pipe exposed on both slopes. This entry matches the Drainage or Irrigation Structure referenced in O&M manual (HLM 6.90). Pipe installed under Permit No. 611 in 1934. Section of pipe between shoulders removed and replaced with 30-inch steel pipe under Permit No. 2497 (1959). FS Date: 6/13/2013

View of waterward side. Metal posts near the levee crown.

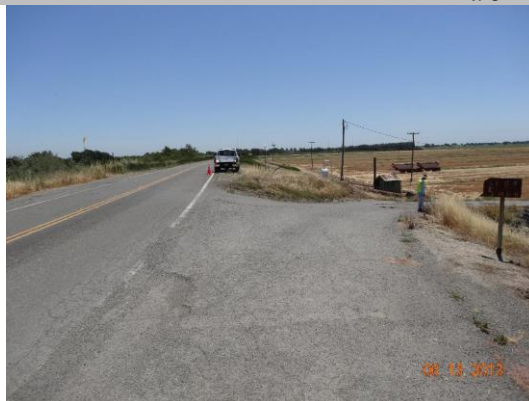
Photo 1 of 2 : UCIP\_SP\_2016\_32543\_59025.jpg

FS\_ID:32543  
DS\_ID:21058  
EP\_NO: N/A  
Repair Type: Non-Urgent  
Crossing Status: Found  
UCIP Comments: Dense vegetation limits the inspector's visibility to identify signs of pipe failure (leaks) along the waterward slope. Recommend removing vegetation along pipe alignment to conduct proper inspection of structure and appurtenances. Need to find pipe owner. Unable to determine status of crossing.  
FIELD\_STRUCT\_DESC: Abandoned 8-inch steel pipe through the levee, 2.7 feet below the crown. Siphon breaker on apex of pipe at landward shoulder. Surge chamber at landward toe. Pump near waterward toe. Pipe exposed on landward side. (USACE-1959). Concrete platform 4 feet by 3 feet located on landward toe. 3-inch conduit runs along 8-inch steel pipe. This entry matches the Drainage or Irrigation Structure referenced in O&M manual (HLM 6.90).  
FS Date: 6/13/2013

Overview of levee crown--multiple crossings within 50 foot stretch.

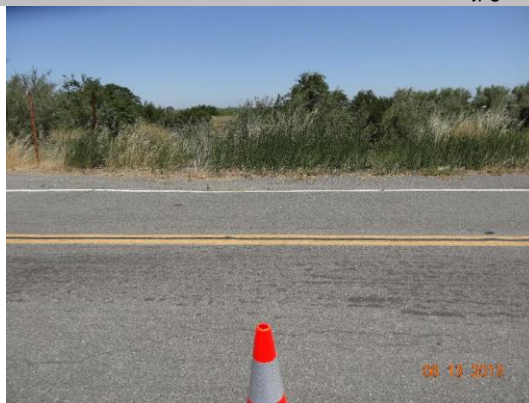
Photo 2 of 2 : UCIP\_SP\_2016\_32543\_59027.jpg

View levee crown at crossing.

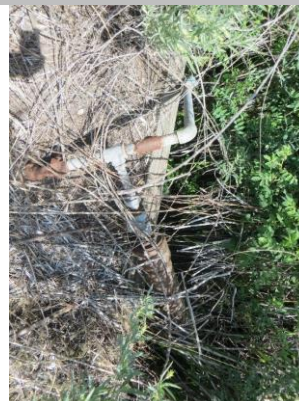
Photo 1 of 2 : UCIP\_SP\_2016\_44748\_73948.jpg

LM Start	6.41	Rating **	M	Issue No.	150
LM End	6.41	Issue Type +	En	Location *	LS
Category	Supplemental			GPS Latitude/Longitude	
				Start	End
Item	DWR UCIP Field Study			38.290356 °	38.290356 °
				-121.627349 °	-121.627349 °
DWR ID					
Comment Code					
Inspector Comment					
FS_ID:44748					
DS_ID:21027					
EP_NO: N/A					
Repair Type: Non-Urgent					
Crossing Status: Found					
UCIP Comments: Pipe appears abandoned and if so should be done so properly.					
FIELD_STRUCT_DESC: 2 of 2: 4-inch steel pipe through the levee, 7.3 feet below the crown. (USACE-1959). Pipe visible on upstream side of wooden platform of WS slope. This entry matches the Drainage or Irrigation Structure referenced in O&M manual (HLM 6.90).					
FS Date: 4/23/2015

4-inch pipe connected to smaller galvanized iron pipe on WS slope.

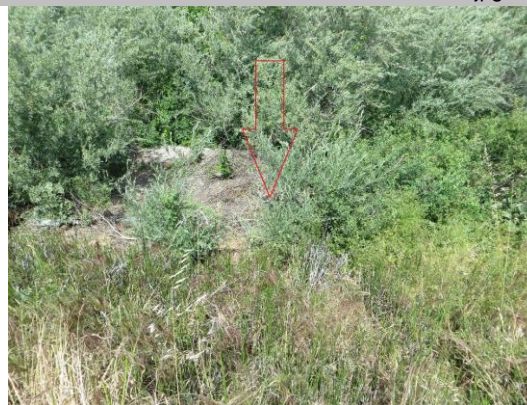
Photo 2 of 2 : UCIP\_SP\_2016\_44748\_73947.jpg

Pipe visible on upstream side of wooden platform on the WS slope.

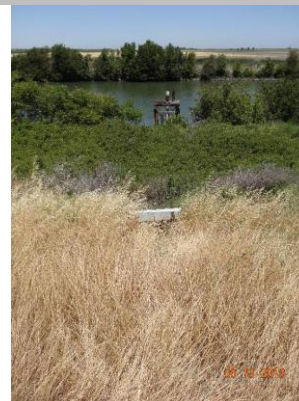
Photo 1 of 2 : UCIP\_SP\_2016\_32544\_59034.jpg

Comment Code					
Inspector Comment					
FS_ID:32544 DS_ID:21060 EP_NO: N/A Repair Type: Non-Urgent Crossing Status: Found UCIP Comments: Dense vegetation limits the inspector's visibility to identify signs of pipe failure (leaks) along the slope. Recommend removing vegetation along pipe alignment to conduct proper inspection of structure and appurtenances. Walkway missing but platform remain on the waterward side. FIELD_STRUCT_DESC: 12-inch pipe through the levee, 6.5 feet below the crown. Switch panel on waterward slope. Pump on pile structure in stream. (USACE-1959). This entry matches the Drainage or Irrigation Structure referenced in O&M manual (HLM 7.30). FS Date: 6/13/2013

View of waterward side. Support piles, conduit line, and pump visible on waterward side. Dense vegetation covers waterward slope.

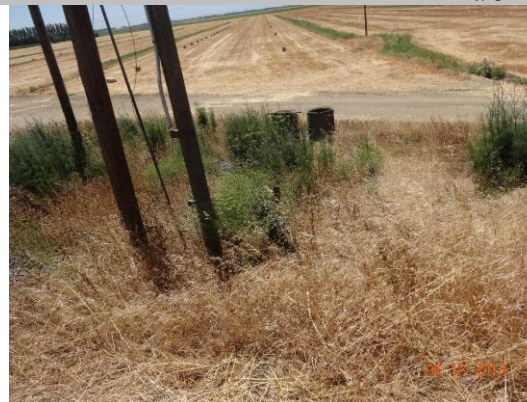
Photo 2 of 2 : UCIP\_SP\_2016\_32544\_59033.jpg

View of standpipes located on landward side.

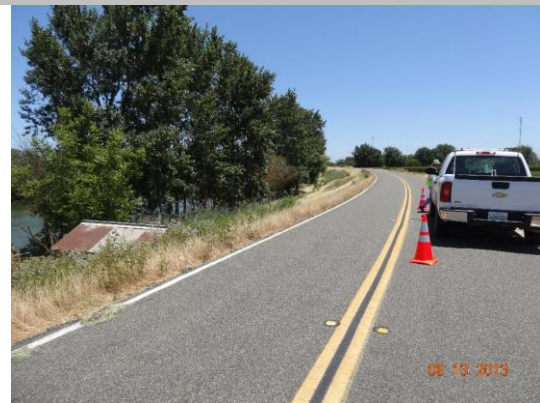
Photo 1 of 2 : UCIP\_SP\_2016\_46834\_33471.jpg

Comment Code					
Inspector Comment					
FS_ID:46834 DS_ID:21061 EP_NO: N/A Repair Type: Non-Urgent Crossing Status: Found UCIP Comments: 11/19/2015 DWR Inspector (H. Phillips) coordinated with LMA superintendent and the owner for this crossing is Walter Koeing, APN No. 042220040. According to LMA superintendent owner installed filter system with fence on landward side and fence around pump in 2012. Pipe not replaced in 2012, this pipe would be a good candidate for internal inspection since the installation date for this crossing was recorded as 1946.06/13/2013 Conduit visible on landward side; new gate on WS toe; filtration system with security fence; Pipe has been upgraded--need permit authorizing work and owner. Dense vegetation limits the inspector's visibility to identify signs of pipe failure (leaks) along the waterward slope. Recommend removing vegetation along pipe alignment to conduct proper inspection of structure and appurtenances. FIELD_STRUCT_DESC: 8-inch steel pipe through the levee, 3.7 feet below the crown. Siphon breaker and service pole on landward slope. 2-inch conduit runs parallel to 8-inch steel pipe. Pump in pump house on waterward slope. (USACE-1959). This entry matches the Drainage or Irrigation Structure referenced in O&M manual (HLM 8.00). FS Date: 6/13/2013

Overview of levee crown.

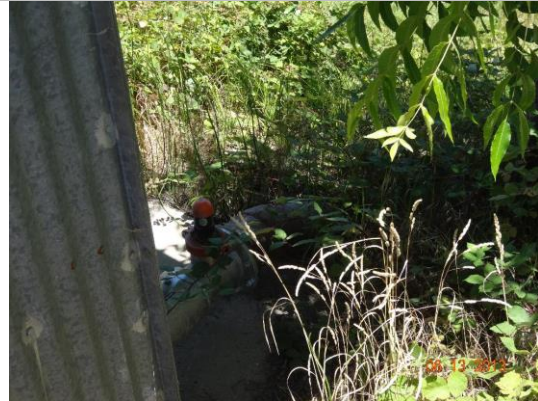
Photo 2 of 2 : UCIP\_SP\_2016\_46834\_33468.jpg

Item	DWR UCIP Field Study			38.287837 °	38.287837 °	
				-121.613453 °	-121.613453 °	
DWR ID						
Comment Code						
Inspector Comment						
FS_ID:46834 DS_ID:21061 EP_NO: N/A Repair Type: Non-Urgent Crossing Status: Found UCIP Comments: 11/19/2015 DWR Inspector (H. Phillips) coordinated with LMA superintendent and the owner for this crossing is Walter Koeing, APN No. 042220040. According to LMA superintendent owner installed filter system with fence on landward side and fence around pump in 2012. Pipe not replaced in 2012, this pipe would be a good candidate for internal inspection since the installation date for this crossing was recorded as 1946.06/13/2013 Conduit visible on landward side; new gate on WS toe; filtration system with security fence; Pipe has been upgraded--need permit authorizing work and owner. Dense vegetation limits the inspector's visibility to identify signs of pipe failure (leaks) along the waterward slope. Recommend removing vegetation along pipe alignment to conduct proper inspection of structure and appurtenances. FIELD_STRUCT_DESC: 8-inch steel pipe through the levee, 3.7 feet below the crown. Siphon breaker and service pole on landward slope. 2-inch conduit runs parallel to 8-inch steel pipe. Pump in pump house on waterward slope. (USACE-1959). This entry matches the Drainage or Irrigation Structure referenced in O&M manual (HLM 8.00). FS Date: 6/13/2013

Pipe connection after pump station.

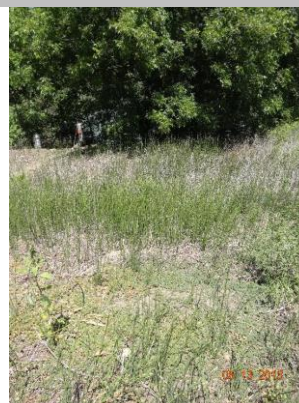
Photo 2 of 2 : UCIP\_SP\_2016\_32545\_59042.jpg

FS\_ID:32545  
DS\_ID:21063  
EP\_NO: 11812  
Repair Type: Urgent  
Crossing Status: Found  
UCIP Comments: Open cut section of levee on LS slope 8 foot wide-- repair work needed. Abandoned pump on waterward berm. Dense vegetation--Recommend removing vegetation along pipe alignment to conduct proper inspection of structure and appurtenances on waterward side.  
FIELD\_STRUCT\_DESC: 14-inch steel pipe and 1.25-inch electrical conduit through the levee, both 3.0 feet below the crown. Cutoff wall around pipe and conduit at center of levee. Siphon breaker on apex of pipe at landward shoulder. Slant pump on waterward slope. Discharge structure at landward toe. Rock revetment on waterward slope. (Permit No. 11812-1976)  
FS Date: 6/7/2013

View of waterward side--pump located at the berm edge.

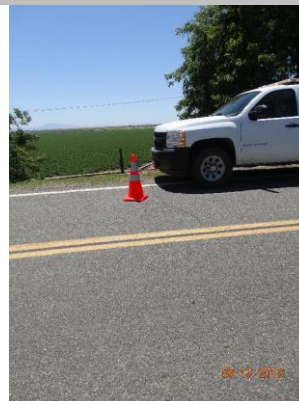
Photo 1 of 2 : UCIP\_SP\_2016\_32546\_59047.jpg

Comment Code					
Inspector Comment					
FS_ID:32546 DS_ID:21064 EP_NO: N/A Repair Type: Non-Urgent Crossing Status: Found UCIP Comments: Debris (pipe section) located on waterward berm. Dense vegetation limits the inspector's visibility to identify signs of pipe failure (leaks) along the waterward slope. Recommend removing vegetation along pipe alignment to conduct proper inspection of structure and appurtenances. FIELD_STRUCT_DESC: 8-inch steel pipe through the levee, 2.7 feet below the crown. Pump in pump house at landward toe. (USACE-1959). This entry matches the Drainage or Irrigation Structure referenced in O&M manual (HLM 8.20). FS Date: 6/13/2013

View of levee crown at crossing.

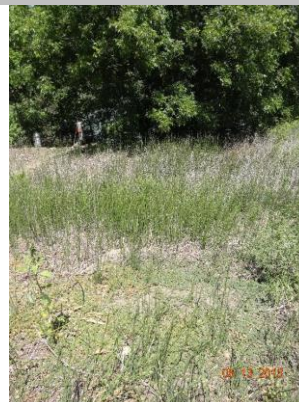
Photo 2 of 2 : UCIP\_SP\_2016\_32546\_59048.jpg

View of waterward side--dense vegetation limits visibility of 8-inch steel pipe. Pump belongs to another crossing.

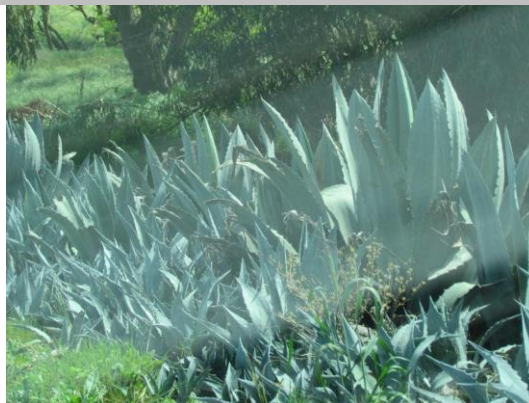
Photo 1 of 1 : SP\_2016\_RD0501\_171\_41\_20160505\_00068.jpg

LM Start	7.65	Rating **	U	Issue No.	41
LM End	7.70	Issue Type +	Ma	Location *	LS
Category	Earthen Levee			GPS Latitude/Longitude	
				Start	End
Item	Vegetation			38.285813 °	38.285537 °
				-121.607003 °	-121.606138 °
DWR ID	DWR_RD0501_03_s_2016_41				
Comment Code					
V2 : Remove the wild growth other than native grasses from the levee slopes.					
Inspector Comment					
This plant growth listed at this location needs to be controlled. This type of plants grows very fast and will completely cover the levee section. (Agave Americana) common names century plant, maguey, or American aloe.

Looking downstream from levee mile 7.65-7.70 wild plant growth covering the landside shoulder and slope.

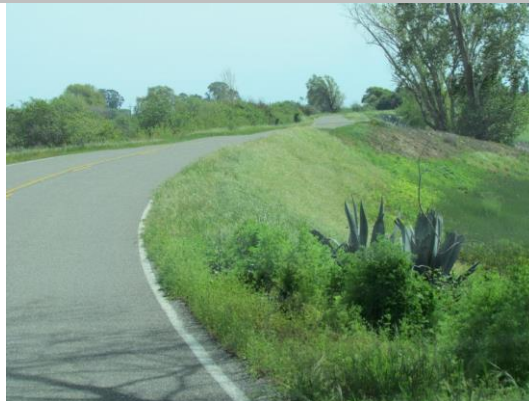
Photo 1 of 1 : SP\_2016\_RD0501\_172\_14\_20160505\_00028.jpg

LM Start	0.00	Rating **	A	Issue No.	14
LM End	2.17	Issue Type +	Ma	Location *	LS
Category	Earthen Levee			GPS Latitude/Longitude	
				Start	End
Item	Vegetation			38.285493 °	38.255978 °
				-121.606042 °	-121.601013 °
DWR ID	DWR_RD0501_04_s_2016_14				
Comment Code					
V1 : Control annual grass and weeds on the levee slopes and easements.					
Inspector Comment					
Levee section looks good from 0.00 - 2.17 landside slope.

Looking downstream from levee mile 0.00 - 2.17 landside of Unit 4.

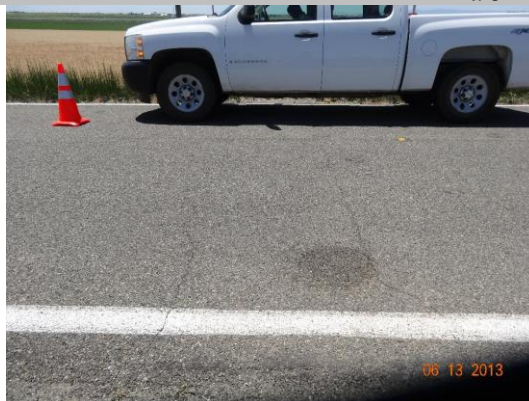
Photo 1 of 2 : UCIP\_SP\_2016\_32547\_59050.jpg

FS\_ID:32547  
DS\_ID:21080  
EP\_NO: 18135  
Repair Type: Non-Urgent  
Crossing Status: Found  
UCIP Comments: Cracks visible on levee crown could be associated with pipe vibration or settlement. Burrow activity on landward side. Recommend removing vegetation along pipe alignment on landward side to conduct proper inspection of structure and appurtenances.  
FIELD\_STRUCT\_DESC: 10-inch iron pipe through the levee, 3.5 feet below the crown. Cutoff wall around pipe at landward shoulder. Slant pump and pump house on waterward slope. Concrete standpipe and power pole at landward toe. Service pole on landward slope. Pipe exposed on both slopes. (Permit No. 2446-1957) Section of pipe under levee crown, between both shoulders, was removed and replaced with a 10-inch steel pipe under Permit No. 18135 (2006). Two crossings nearby 10-inch pipe and 8-inch pipe crossings are approximately 5 feet apart.

View of levee crown.

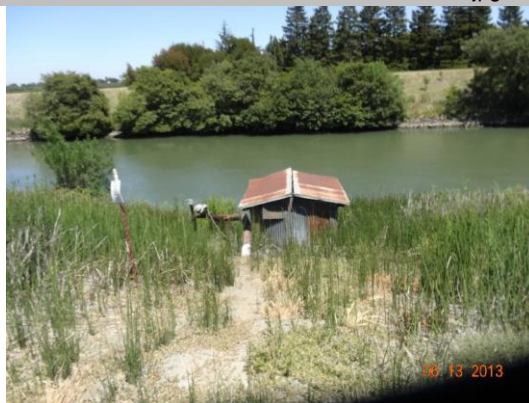
Photo 2 of 2 : UCIP\_SP\_2016\_32547\_59051.jpg

Overview of waterward side--2 crossings located within 5 feet.

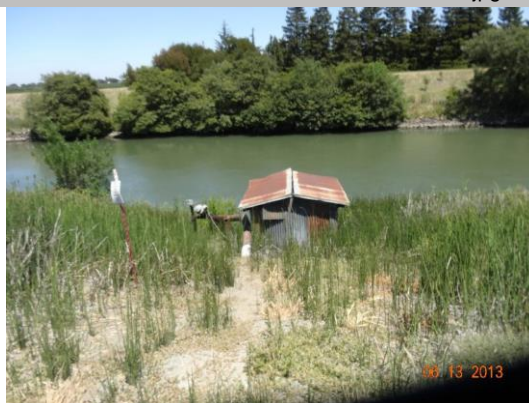
Photo 2 of 2 : UCIP\_SP\_2016\_32548\_59058.jpg

FS\_ID:32548  
DS\_ID:21079  
EP\_NO: 2446  
Repair Type: Non-Urgent  
Crossing Status: Found  
UCIP Comments: Permit documents indicate that pipe does not appear to be properly grouted. Crossing needs to be properly abandoned per CVFPB Title 23--need to find owner. Also recommend removing vegetation along pipe alignment to conduct proper inspection of structure and appurtenances.  
FIELD\_STRUCT\_DESC: Abandoned 8-inch steel pipe through the levee, 6.0 feet below the crown. Pump on waterward side. Steel plate welded on waterward end. (USACE-1959). This entry matches the Drainage or Irrigation Structure referenced in O&M manual (HLM 0.60). Pipe was abandoned under Permit No. 2446 (1957). 10-inch steel pipe is located approximately 5 feet downstream.  
FS Date: 6/13/2013

Overview of waterward side. Two crossings, 10 inch and 8 inch pipelines, less than 5 feet apart.

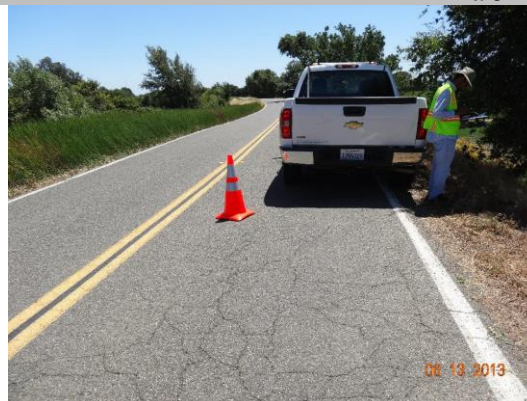
Photo 1 of 2 : UCIP\_SP\_2016\_32549\_59065.jpg

Comment Code					
Inspector Comment					
FS_ID:32549 DS_ID:21072 EP_NO: N/A Repair Type: Urgent Crossing Status: Found UCIP Comments: Pipe has deteriorated-holes present on landward side. Need to contact owner. Unable to determine if crossing is still being used. Dense vegetation limits the inspector's visibility to identify signs of pipe failure (leaks) along the waterward slope. Recommend removing vegetation along pipe alignment to conduct proper inspection of structure and appurtenances. FIELD_STRUCT_DESC: Abandoned 8-inch steel pipe through the levee, 2.7 feet below the crown. Pump on waterward side. Steel plate welded on waterward end. (USACE-1959). This entry matches the Drainage or Irrigation Structure referenced in O&M manual (HLM 1.10). FS Date: 6/13/2013

View of levee crown at crossing.

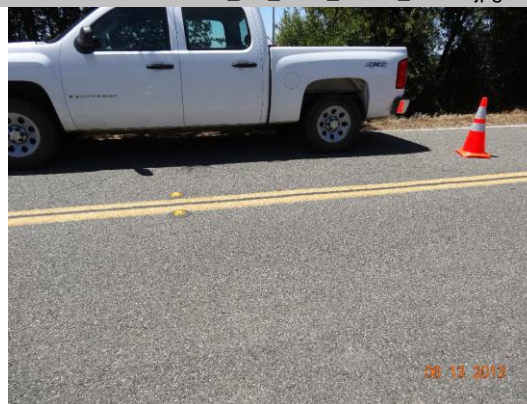
Photo 2 of 2 : UCIP\_SP\_2016\_32549\_59066.jpg

View of levee crown at crossing.

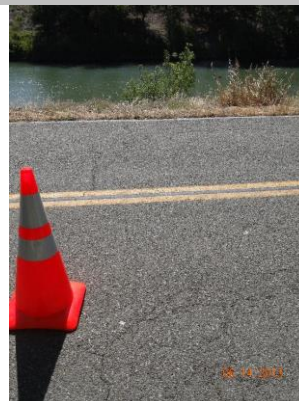
Photo 1 of 2 : UCIP\_SP\_2016\_32550\_59068.jpg

FS\_ID:32550  
DS\_ID:21073  
EP\_NO: N/A  
Repair Type: Non-Urgent  
Crossing Status: Indicator Found  
UCIP Comments: Unable to determine if the pipe goes through the levee. need As-Built drawings; Need owner information.  
FIELD\_STRUCT\_DESC: 1.5-inch conduit through the levee, 2.0 feet below the crown. Pole and anchor on landward slope.  
FS Date: 6/13/2013

Levee crown at crossing.

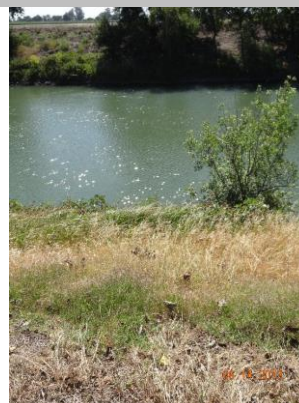
Photo 2 of 2 : UCIP\_SP\_2016\_32550\_59067.jpg

View of waterward side.

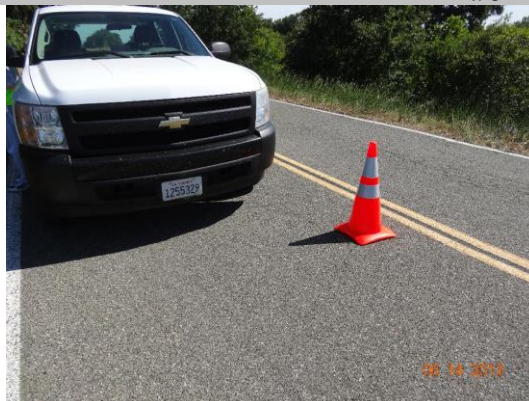
Photo 1 of 2 : UCIP\_SP\_2016\_32551\_59070.jpg

Comment Code					
Inspector Comment					
FS_ID:32551					
DS_ID:21074					
EP_NO: N/A					
Repair Type: Non-Urgent					
Crossing Status: Found					
UCIP Comments: Unable to determine status of crossing. Pipe visible on waterward side--could be the pipe that was supposed to be removed under permit number 13983 (1985). Also present is a 1.5 inch conduit along the 8 inch pipe. Need to coordinate with owner.					
FIELD_STRUCT_DESC: 8-inch steel pipe through the levee, 6.4 feet below the crown. Pump on pile structure in stream. Service pole on landward slope. (USACE-1959). This entry matches the Drainage or Irrigation Structure referenced in O&M manual (HLM 1.30). Pipe should have been removed and replaced with 12-inch pipe under Permit No. 13983 (1985).					
FS Date: 6/13/2013

View of levee crown at crossing.

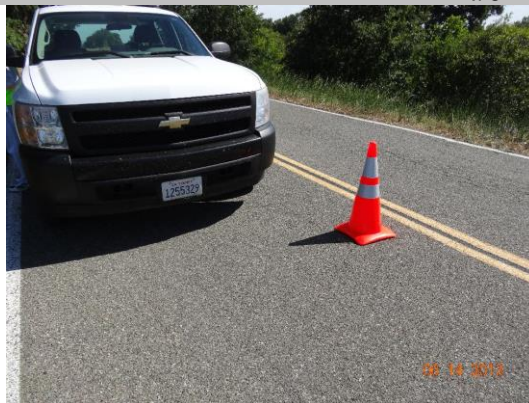
Photo 1 of 2 : UCIP\_SP\_2016\_32552\_59073.jpg

Comment Code					
Inspector Comment					
FS_ID:32552 DS_ID:21095 EP_NO: 13983 Repair Type: Non-Urgent Crossing Status: Found UCIP Comments: Abandoned pipe was to be removed during the installation of new 12-inch pipe crossing. Need to contact pipe owner. Unable to confirm crossing--need additional records for crossing. FIELD_STRUCT_DESC: 12-inch steel pipe through the levee, 5.0 feet below the crown. Cutoff wall around pipe at center of levee. Siphon breaker on apex of pipe at landward shoulder. Pump on pile structure in stream. Service pole on landward slope. Pipe connects to 10-inch steel pipe along the landward slope at the shoulder, and similarly to pre-existing 8-inch pipe on the watereward side. (Permit No. 13983-1985) FS Date: 6/13/2013

View of levee crown at crossing.

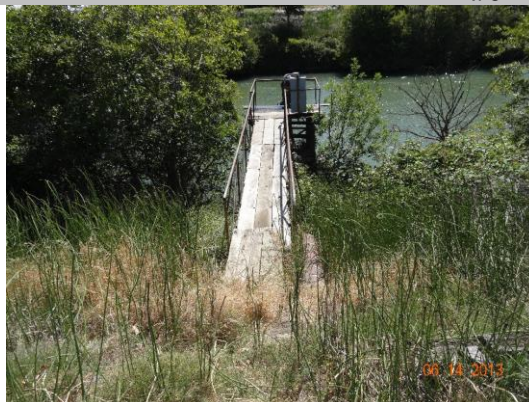
Photo 2 of 2 : UCIP\_SP\_2016\_32552\_59076.jpg

View of waterward side--walkway, pump, conduit, and pipe.

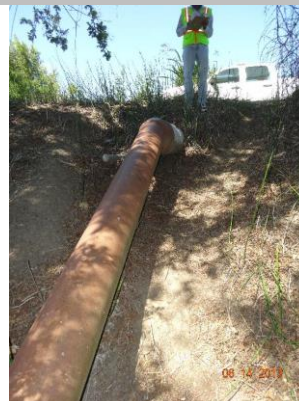
Photo 1 of 2 : UCIP\_SP\_2016\_44471\_33491.jpg

Comment Code					
Inspector Comment					
FS_ID:44471 DS_ID:21076 EP_NO: 16906 Repair Type: Non-Urgent Crossing Status: Found UCIP Comments: Crossing was running during site inspection. Dense vegetation limits the inspector's visibility to identify signs of pipe failure (leaks) along the landward slope. Recommend removing vegetation along pipe alignment to conduct proper inspection of structure and appurtenances. FIELD_STRUCT_DESC: 14-inch steel pipe through the levee, 2.2 feet below the crown. Pump on pile structure in stream. Concrete standpipe on landward side. Pipe is exposed on landward slope. (Permit No. 16906-1999) Two conduits present 3 inch conduit disconnected and 1.5 inch electrical conduit appears to be active. FS Date: 6/13/2013

Waterward side-pipe along slope.

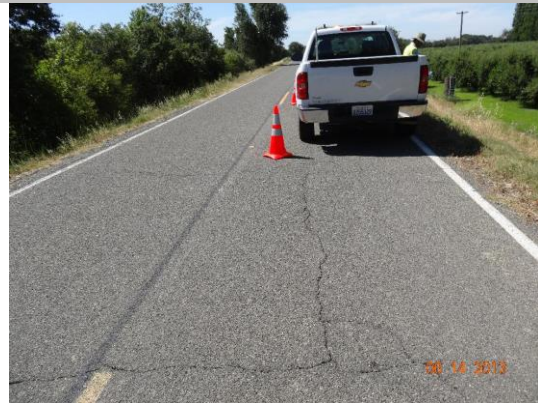
Photo 1 of 2 : UCIP\_SP\_2016\_32553\_59082.jpg

Comment Code					
Inspector Comment					
FS_ID:32553 DS_ID:21077 EP_NO: N/A Repair Type: Non-Urgent Crossing Status: Found UCIP Comments: Dense vegetation limits the inspector's visibility to identify signs of pipe failure (leaks) along the waterward and landward slope. Recommend removing vegetation along pipe alignment to conduct proper inspection of structure and appurtenances. FIELD_STRUCT_DESC: 14-inch steel pipe through the levee, 8.0 feet below the crown. 2 inch conduit goes through levee. Siphon breaker on landward slope. Pump on pile structure in stream. (USACE-1959). This entry matches the Drainage or Irrigation Structure referenced in O&M manual (HLM 2.0). FS Date: 6/13/2013

View of levee crown at crossing.

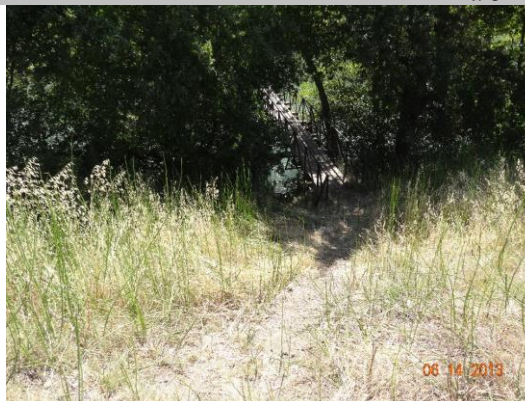
Photo 2 of 2 : UCIP\_SP\_2016\_32553\_59081.jpg

Comment Code						
Inspector Comment						
FS_ID:32553						
DS_ID:21077						
EP_NO: N/A						
Repair Type: Non-Urgent						
Crossing Status: Found						
UCIP Comments: Dense vegetation limits the inspector's visibility to						
identify signs of pipe failure (leaks) along the waterward and landward						
slope. Recommend removing vegetation along pipe alignment to						
conduct proper inspection of structure and appurtenances.						
FIELD_STRUCT_DESC: 14-inch steel pipe through the levee, 8.0 feet						
below the crown. 2 inch conduit goes through levee. Siphon breaker on						
landward slope. Pump on pile structure in stream. (USACE-1959). This						
entry matches the Drainage or Irrigation Structure referenced in O&M						
manual (HLM 2.0).						
FS Date: 6/13/2013

View of waterward side.

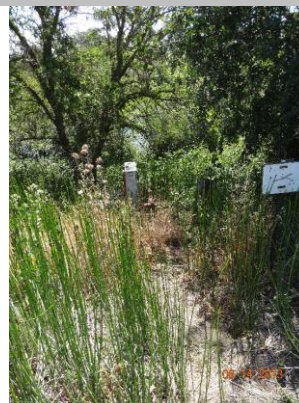
Photo 2 of 2 : UCIP\_SP\_2016\_32863\_59484.jpg

FS\_ID:32863  
DS\_ID:21078  
EP\_NO: N/A  
Repair Type: Non-Urgent  
Crossing Status: Found  
UCIP Comments: Broken concrete box on landward slope. Disturbed soil on waterward slope--unable to determine section disturbed. Dense vegetation limits the inspector's visibility to identify signs of pipe failure (leaks) along the waterwar slope. Recommend removing vegetation along pipe alignment to conduct proper inspection of structure and appurtenances.  
FIELD\_STRUCT\_DESC: Abandoned 6-inch and working 6-inch steel pipes through the levee, 2.5 and 5.0 feet below the crown, respectively. 1.5 inch electrical conduit through levee. Pump in pump house on waterward slope. (USACE-1959). This entry matches the Drainage or Irrigation Structure referenced in O&M manual (HLM 2.30). Pipes are within 5 feet.  
FS Date: 6/13/2013

View of waterward side with dense vegetation along slope.
